TesTrak Data Summary

TesTrak® RealTime

LWD REALTIME LOG - RUN 7

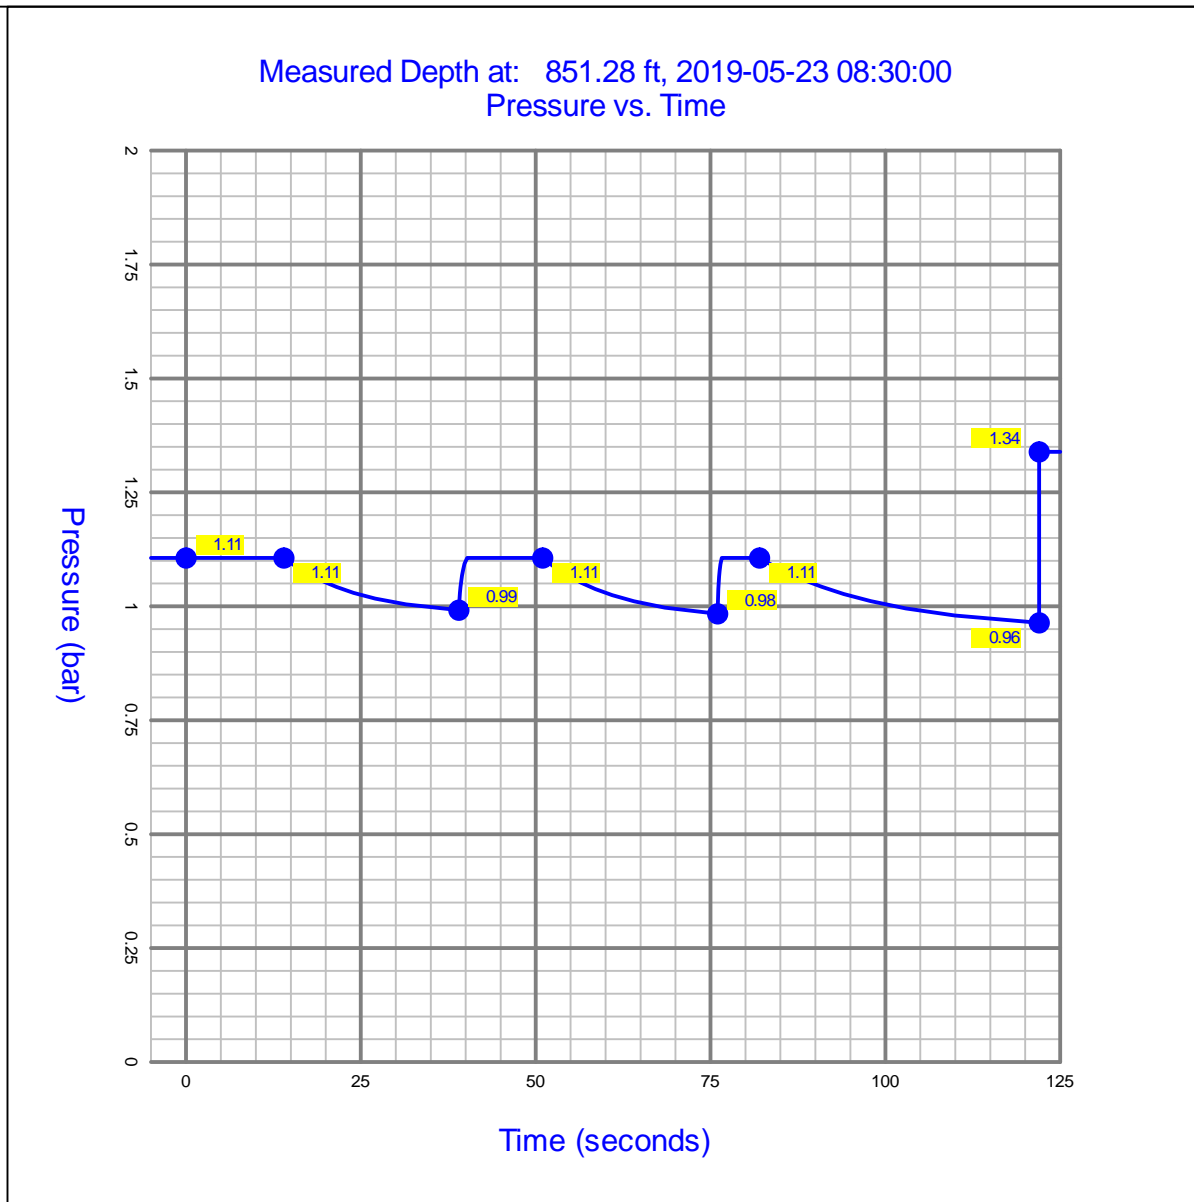
Run #: 7 Station #: 1

Test Option: Low Mobility Test

Measured Depth: (ft) 851.28

True Vertical Depth: (ft) 743.45

Test #	Formation Pressure (bar)	Mobility (mD/cP)	Delta Pressure (bar)
1	0.99		0.00
2	0.98		0.00
3	0.96		0.00

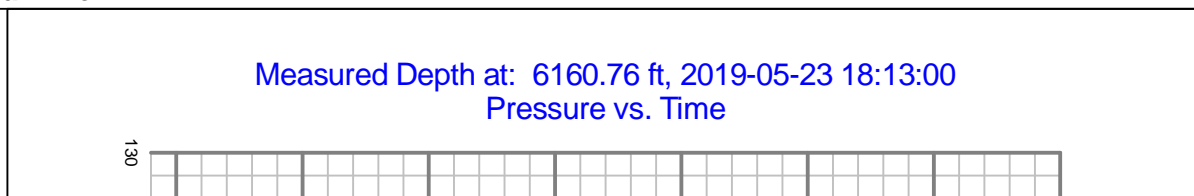
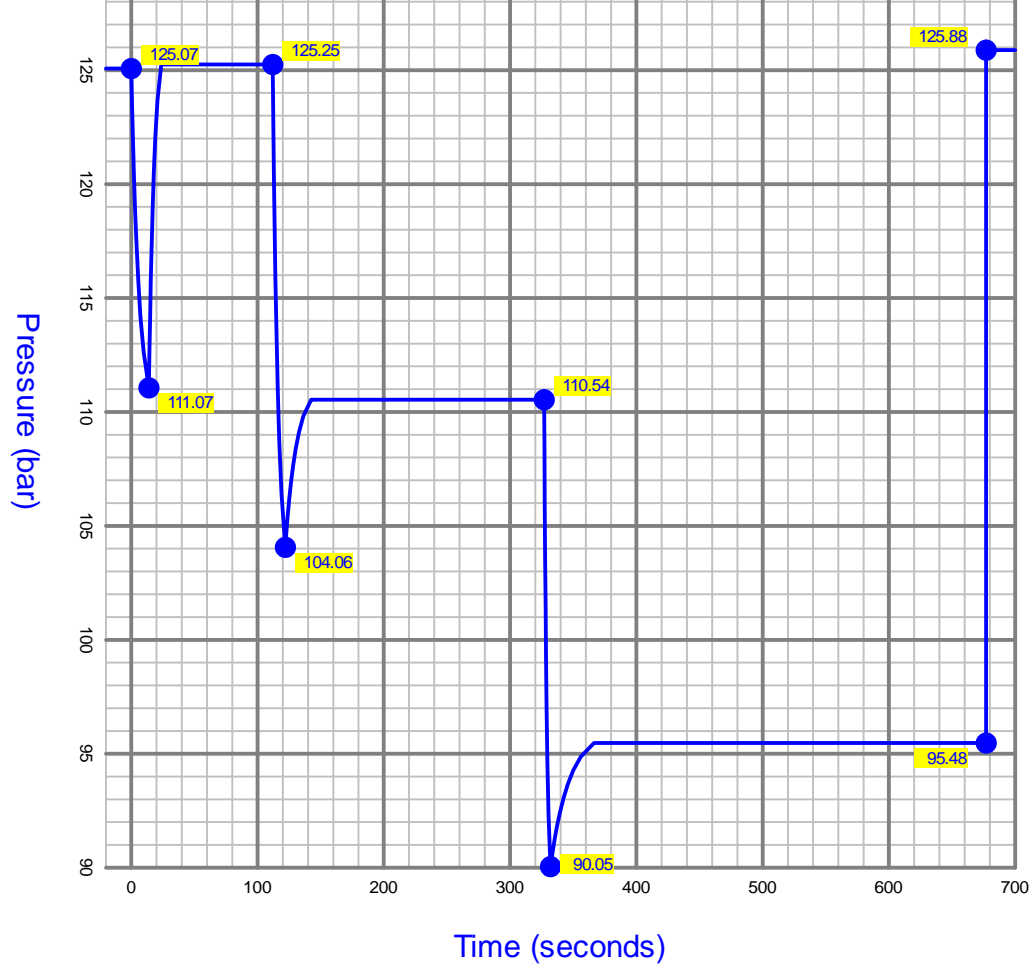
Run #: 7 Station #: 2

Test Option: High Mobility Test

Measured Depth: (ft) 6160.76

Test #	Formation Pressure (bar)	Mobility (mD/cP)	Delta Pressure (bar)
1	125.25		14.01
2	110.54		21.01
3	95.48		35.02

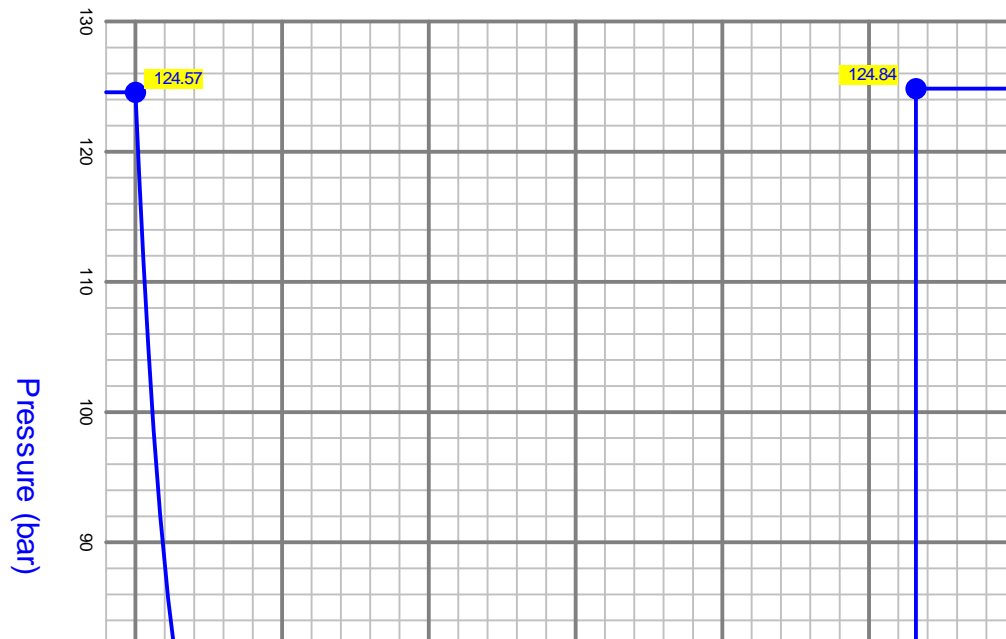
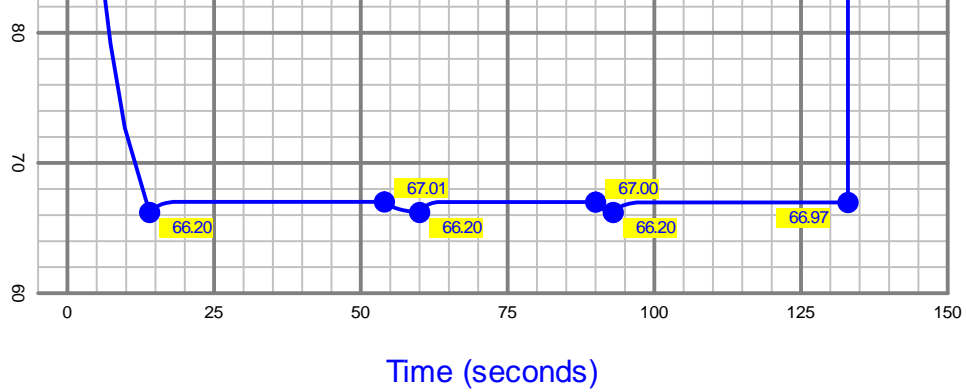
Measured Depth at: 6139.37 ft, 2019-05-23 19:47:00
Pressure vs. Time

Comment: N/A
 Run #: 7 Station #: 3
 Date/Time: 2019-05-23 19:47
 Best Test Number: 0
 Test Option: High Mobility Test
 Measured Depth: (ft) 6139.37
 True Vertical Depth: (ft) 3567.78

Test Result: N/A
 Annular Pressure Before: (bar) 124.57
 Annular Pressure After: (bar) 124.84
 Best Test Pressure: (bar) 67.00
 Tool Face Average: (deg) 168.75
 Quality Bit Best Test: 7
 Pad Travel Distance Exceeded: No

Test #	Formation Pressure (bar)	Mobility (mD/cP)	Delta Pressure (bar)
1	67.01		58.36
2	67.00		58.36
3	66.97		58.36

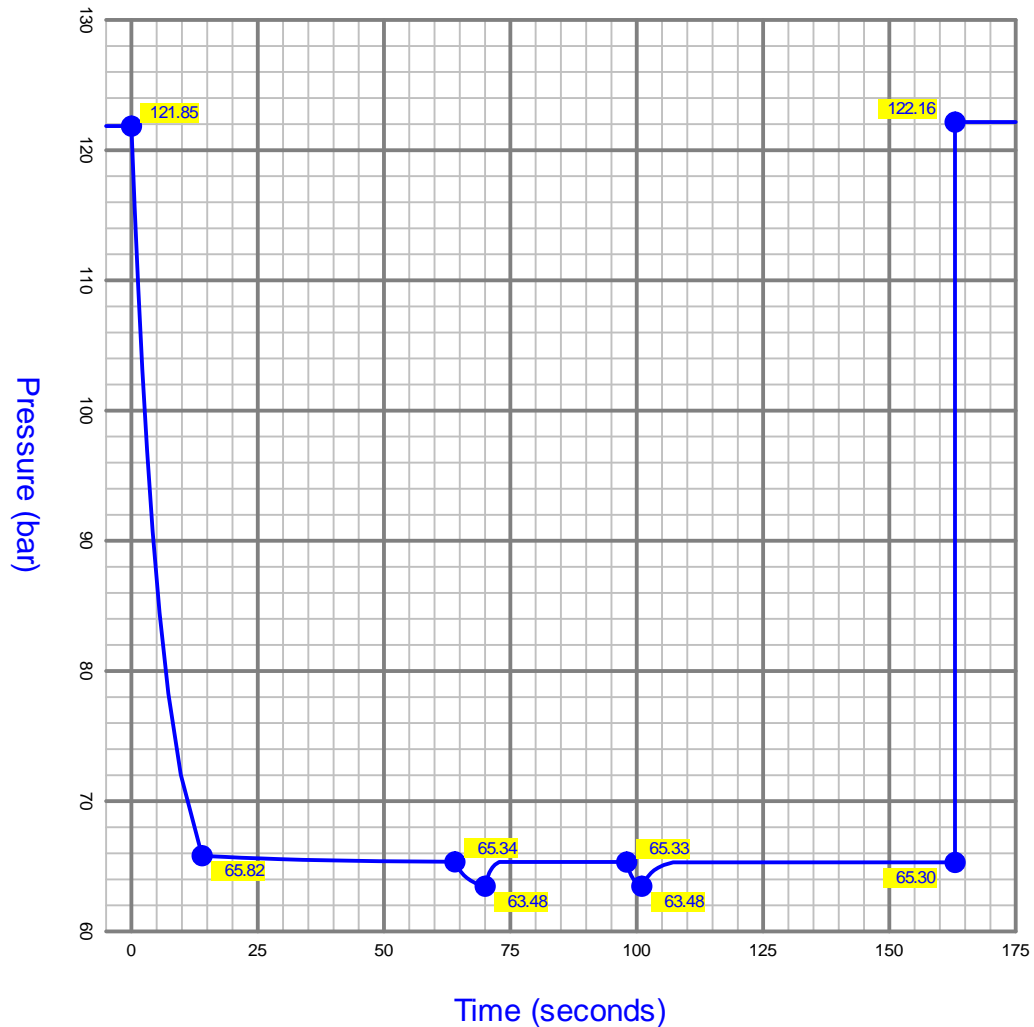
Measured Depth at: 6004.92 ft, 2019-05-23 20:45:00
 Pressure vs. Time

Comment: N/A
 Run #: 7 Station #: 4
 Date/Time: 2019-05-23 20:45

Best test Number: 0
 Test Option: High Mobility Test
 Measured Depth: (ft) 6004.92
 True Vertical Depth: (ft) 3490.78

Best test Pressure: (bar) 65.33
 Tool Face Average: (deg) 157.50
 Quality Bit Best Test: 7
 Pad Travel Distance Exceeded: No

Test #	Formation Pressure (bar)	Mobility (mD/cP)	Delta Pressure (bar)
1	65.34		56.03
2	65.33		58.36
3	65.30		58.36

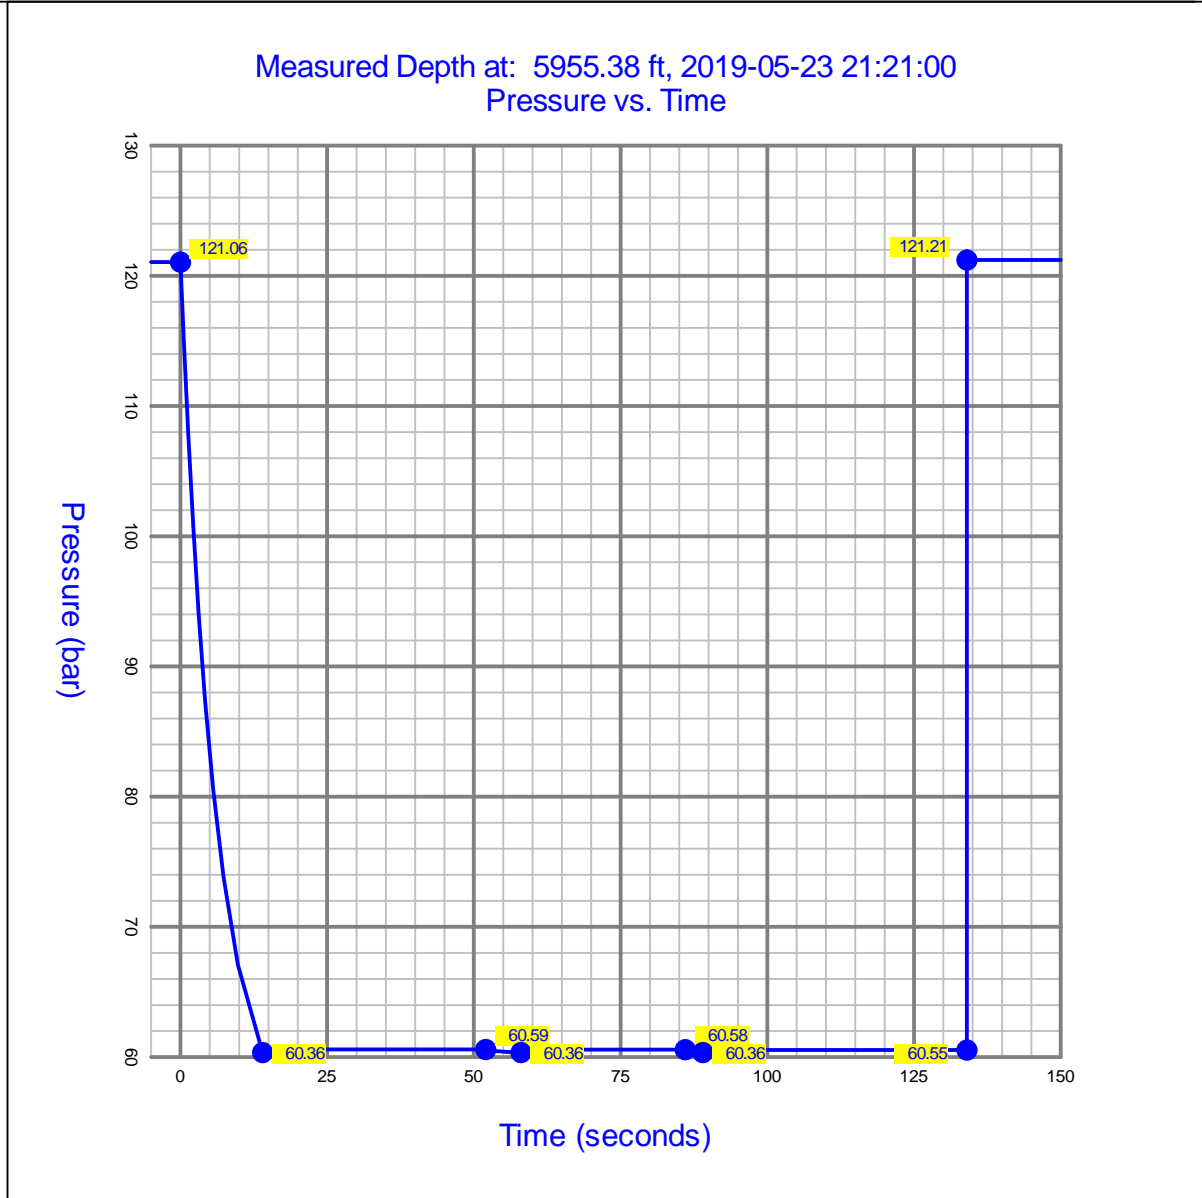
Comment: N/A
 Run #: 7 Station #: 5
 Date/Time: 2019-05-23 21:21
 Best Test Number: 0
 Test Option: High Mobility Test
 Measured Depth: (ft) 5955.38
 True Vertical Depth: (ft) 3462.41

Test Result: N/A
 Annular Pressure Before: (bar) 121.06
 Annular Pressure After: (bar) 121.21
 Best Test Pressure: (bar) 60.58
 Tool Face Average: (deg) 168.75
 Quality Bit Best Test: 7
 Pad Travel Distance Exceeded: No

Test #	Formation Pressure (bar)	Mobility (mD/cP)	Delta Pressure (bar)
1	60.59		60.70
2	60.58		60.70
3	60.55		60.70

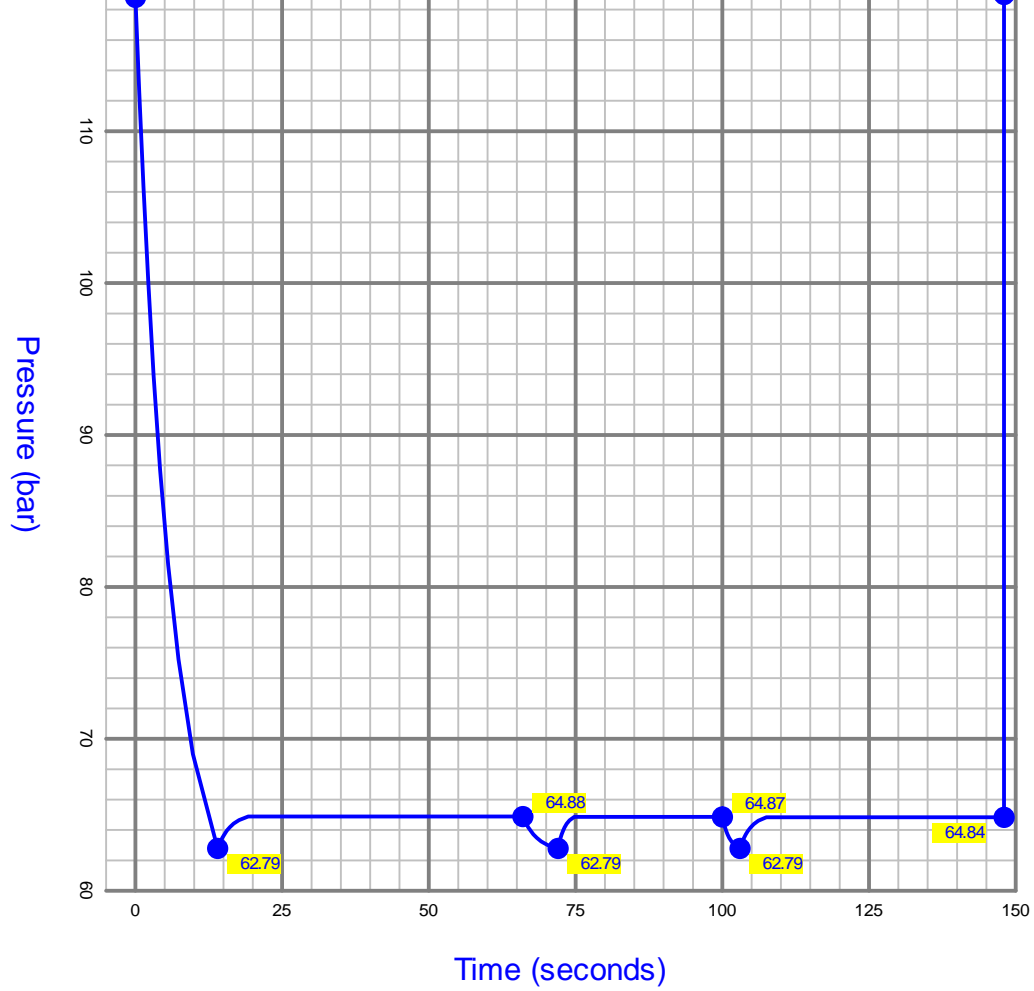
Comment: N/A
 Run #: 7 Station #: 6
 Date/Time: 2019-05-23 22:29
 Best Test Number: 0
 Test Option: High Mobility Test
 Measured Depth: (ft) 5849.05
 True Vertical Depth: (ft) 3401.63

Test Result: N/A
 Annular Pressure Before: (bar) 118.82
 Annular Pressure After: (bar) 119.01
 Best Test Pressure: (bar) 64.84
 Tool Face Average: (deg) 180.00
 Quality Bit Best Test: 7
 Pad Travel Distance Exceeded: No

Test #	Formation Pressure (bar)	Mobility (mD/cP)	Delta Pressure (bar)
1	64.88		56.03
2	64.87		56.03
3	64.84		56.03

Run No.	Stat No.	Date and Time	MD (ft)	TVD (ft)	Annular Pres. Before (bar)	Formation Pressure 1 (bar)	Formation Pressure 2 (bar)	Formation Pressure 3 (bar)	Equiv. Mud Weight (ppg)	Equiv. Mud Weight (ppg)	Equiv. Mud Weight (ppg)	Mud Weight (ppg)	ECD Before (ppg)	Mobility (mD/cP)	Best Pressure (bar)	Qual. Bit # (0-7)
7	1	2019-05-23 08:30	851.28	743.45	1.11	0.99	0.98	0.96	0.0	0.0	0.0	0.0	0.0	103731.0	0.99	4
7	2	2019-05-23 18:13	6160.76	3580.02	125.07	125.25	110.54	95.48	0.0	0.0	0.0	0.0	0.0	2.7	110.54	4
7	3	2019-05-23 19:47	6139.37	3567.78	124.57	67.01	67.00	66.97	0.0	0.0	0.0	0.0	0.0	953.4	67.00	7
7	4	2019-05-23 20:45	6004.92	3490.78	121.85	65.34	65.33	65.30	0.0	0.0	0.0	0.0	0.0	1200.3	65.33	7
7	5	2019-05-23 21:21	5955.38	3462.41	121.06	60.59	60.58	60.55	0.0	0.0	0.0	0.0	0.0	2209.6	60.58	7
7	6	2019-05-23 22:29	5849.05	3401.63	118.82	64.88	64.87	64.84	0.0	0.0	0.0	0.0	0.0	527.6	64.84	7

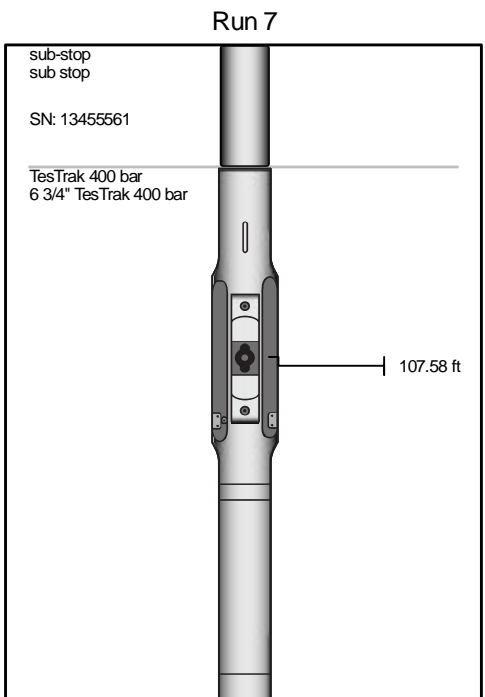
Tool Diagram

CCN
6 3/4" Caliper
Corrected Neutron

ORD
6 3/4" Optimized
Rotational Density

Flex Stab

BCPM
Bi-directional
Communication and
Power Module

stab-mod
Stab Mod
